HISTORIC GROUNDS REPORT
THE CARL S. ENGLISH, JR. BOTANICAL GARDEN
AT THE HIRAM M. CHITTENDEN LOCKS
SEATTLE DISTRICT, CORPS OF ENGINEERS

PREPARED BY RENEE L. FREIER
NOVEMBER, 1989

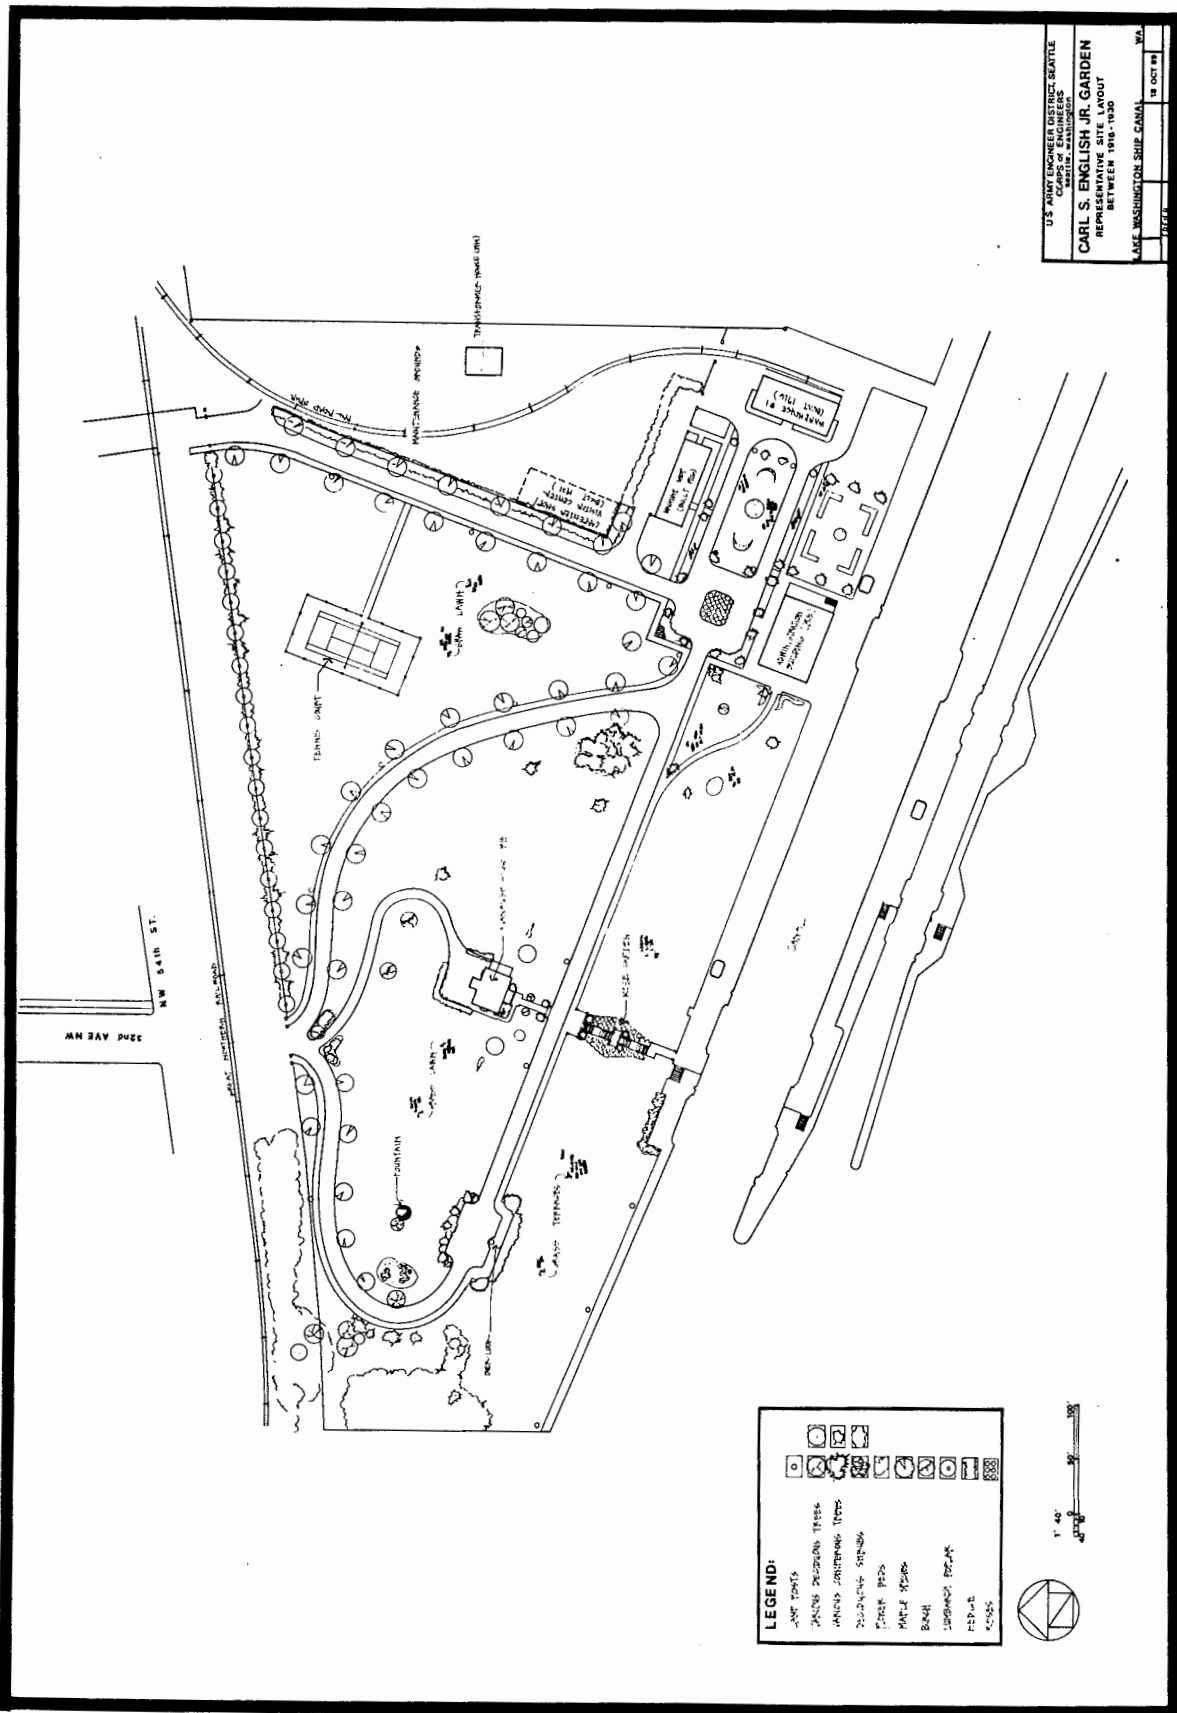
Map C. Carl S. English Botanical Garden Representative Site Layout Between 1915 - 1930

U.S. ARMY ENGINEER DISTRICT SEATTLE
 4000 UNIVERSITY AVENUE
 SEATTLE, WASHINGTON
CARL S. ENGLISH JR. GARDEN
 REPRESENTATIVE SITE LAYOUT
 BETWEEN 1915-1930
 LAKE WASHINGTON SHIP CANAL
 18 OCT 89
 WA

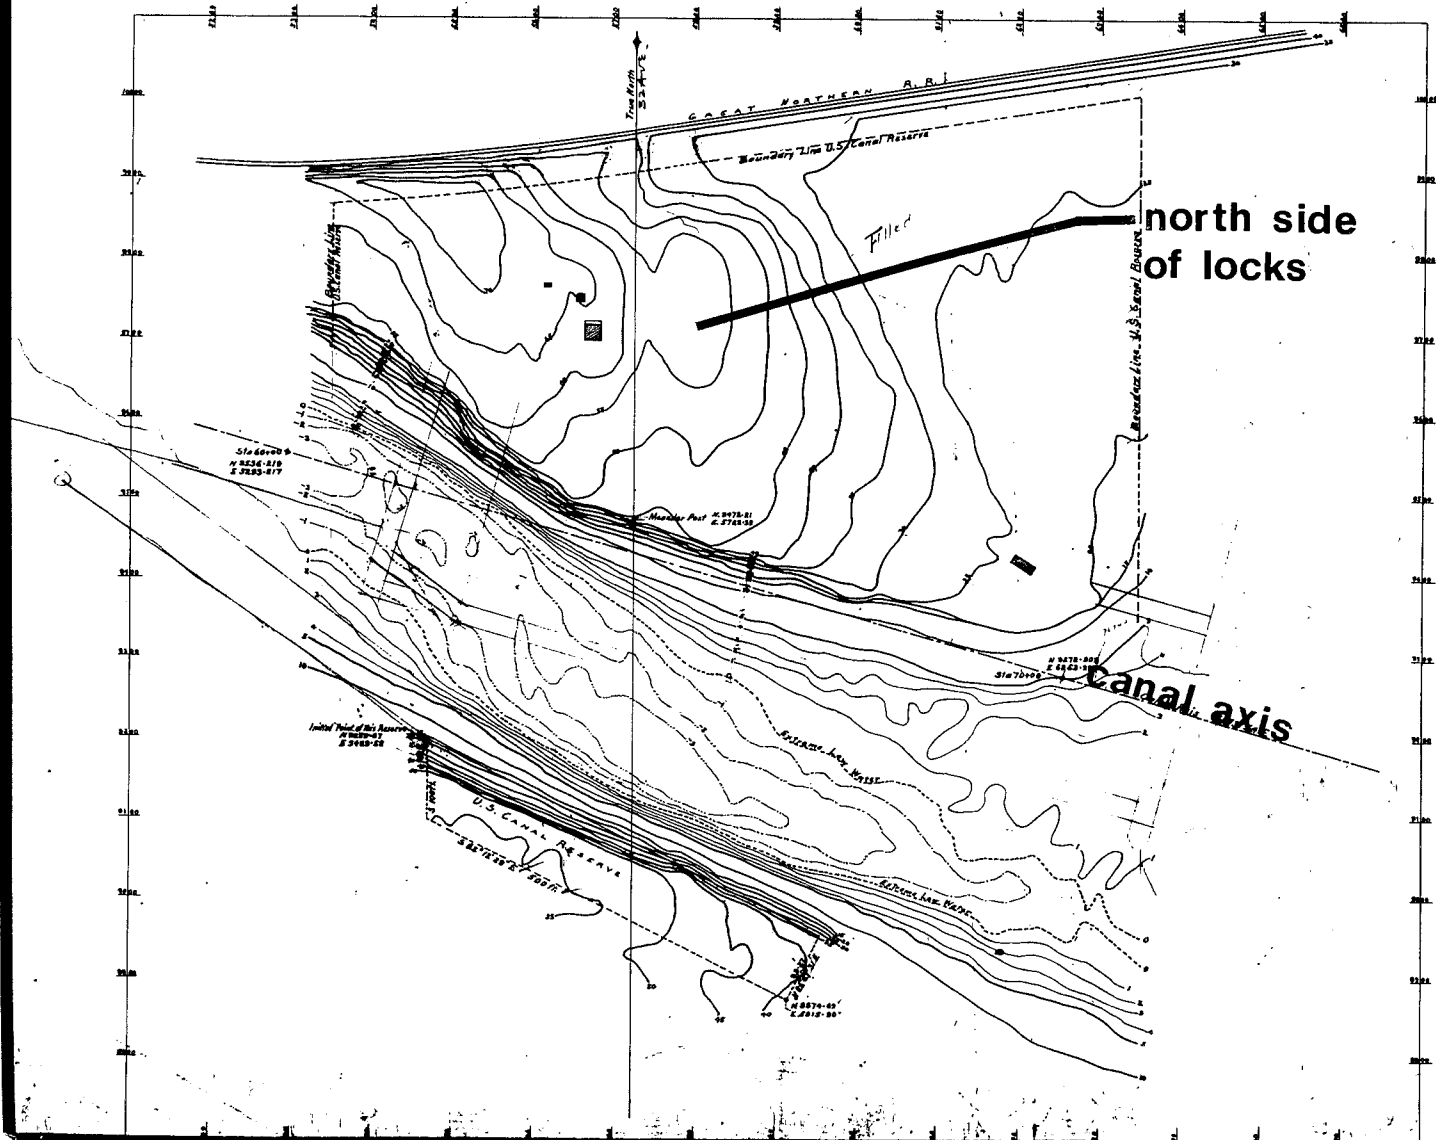
Map F. Topographical Map of Locks Grounds (1901)

Elev 00 = Extreme Low Water.

Datum Extreme low tide.

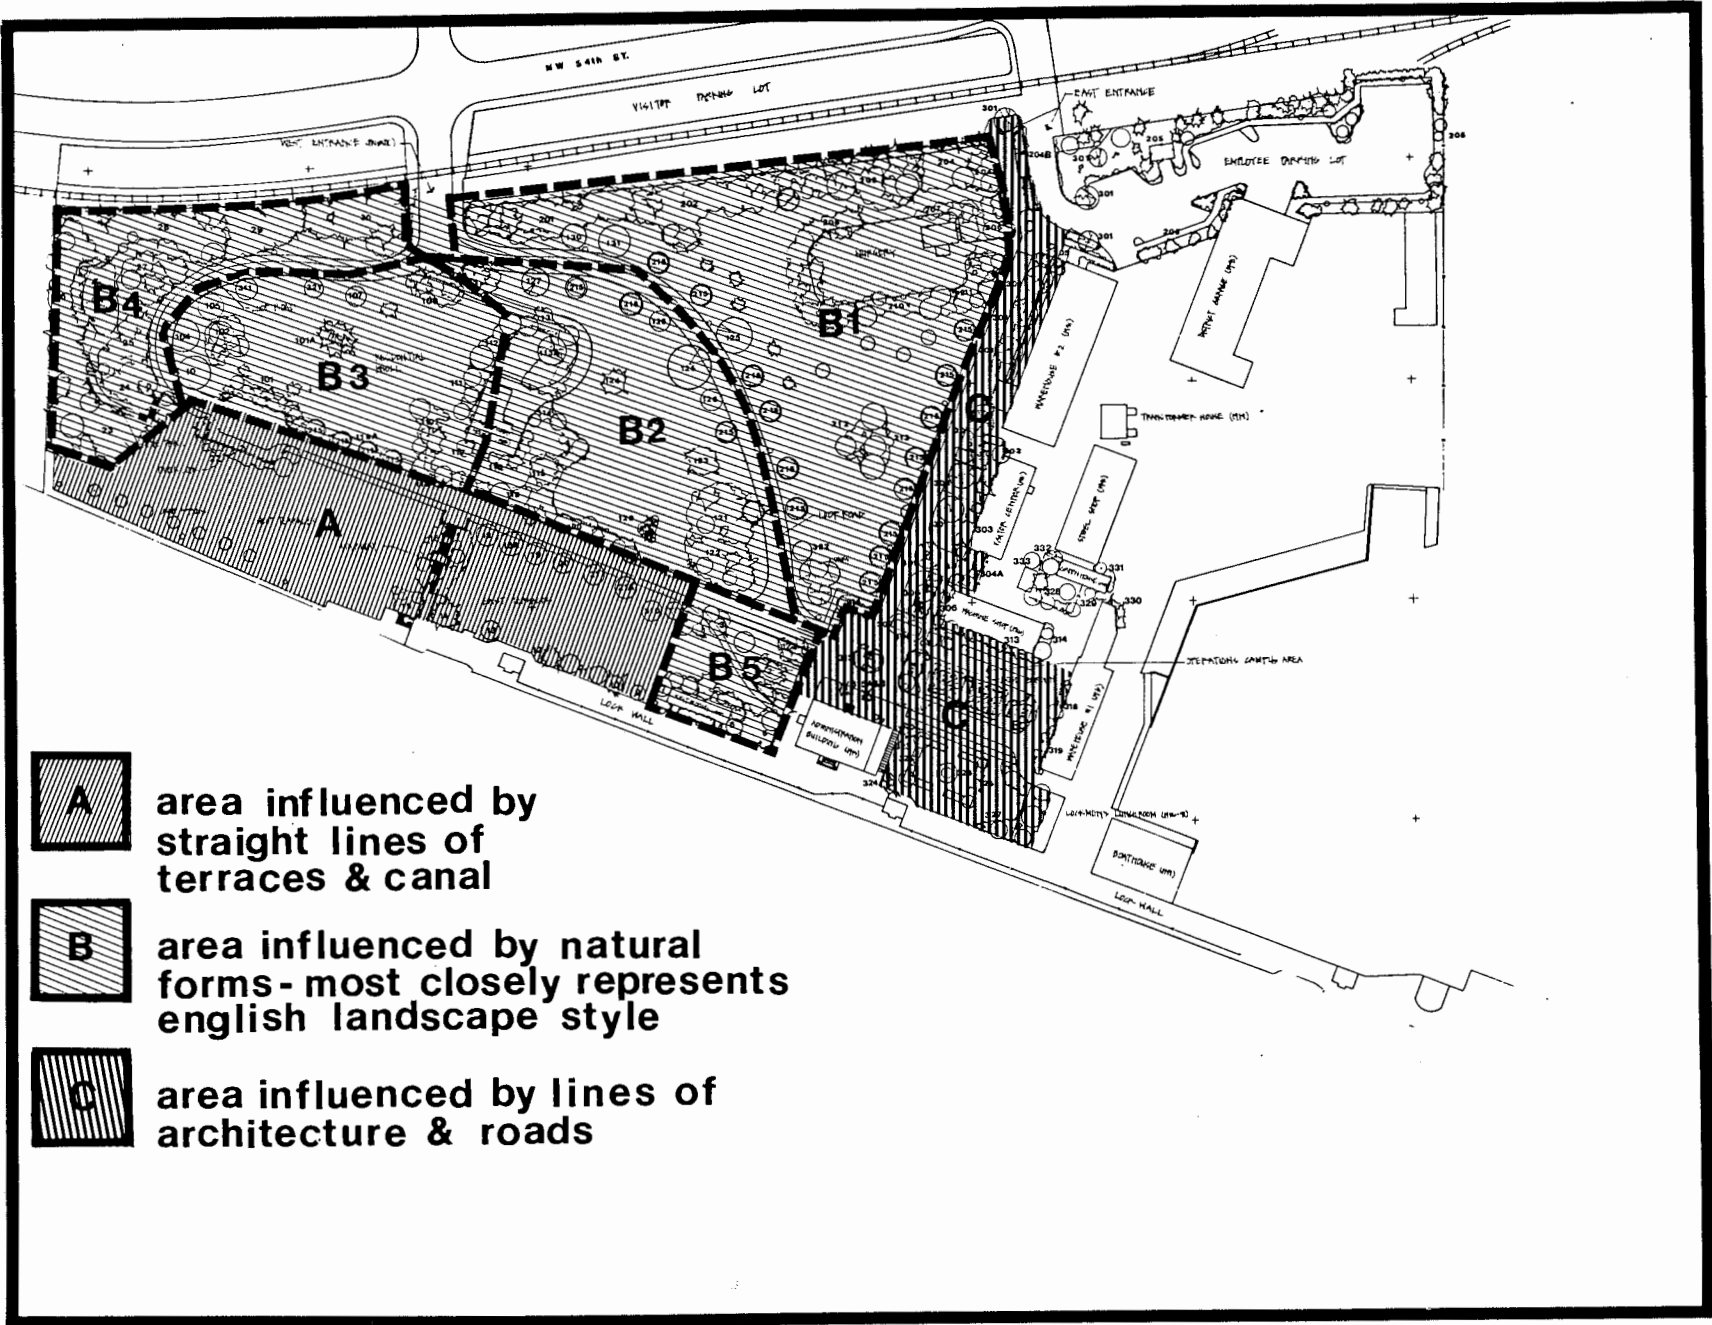
Map I. Organization of Spaces in the Garden

A area influenced by straight lines of terraces & canal

Area A runs adjacent to and parallel with the lock wall and waterway. The five foot terraces characterize this area (photo 38). The straight lines of the lock wall are repeated in the terraces, the lines of trees found both at the top and bottom of the terraces, and in the road and walkway at the top of the slopes. This area is steep with an elevation gain of over 35 feet at the western (steepest) end. The steepness and terraces taper off toward the east end.

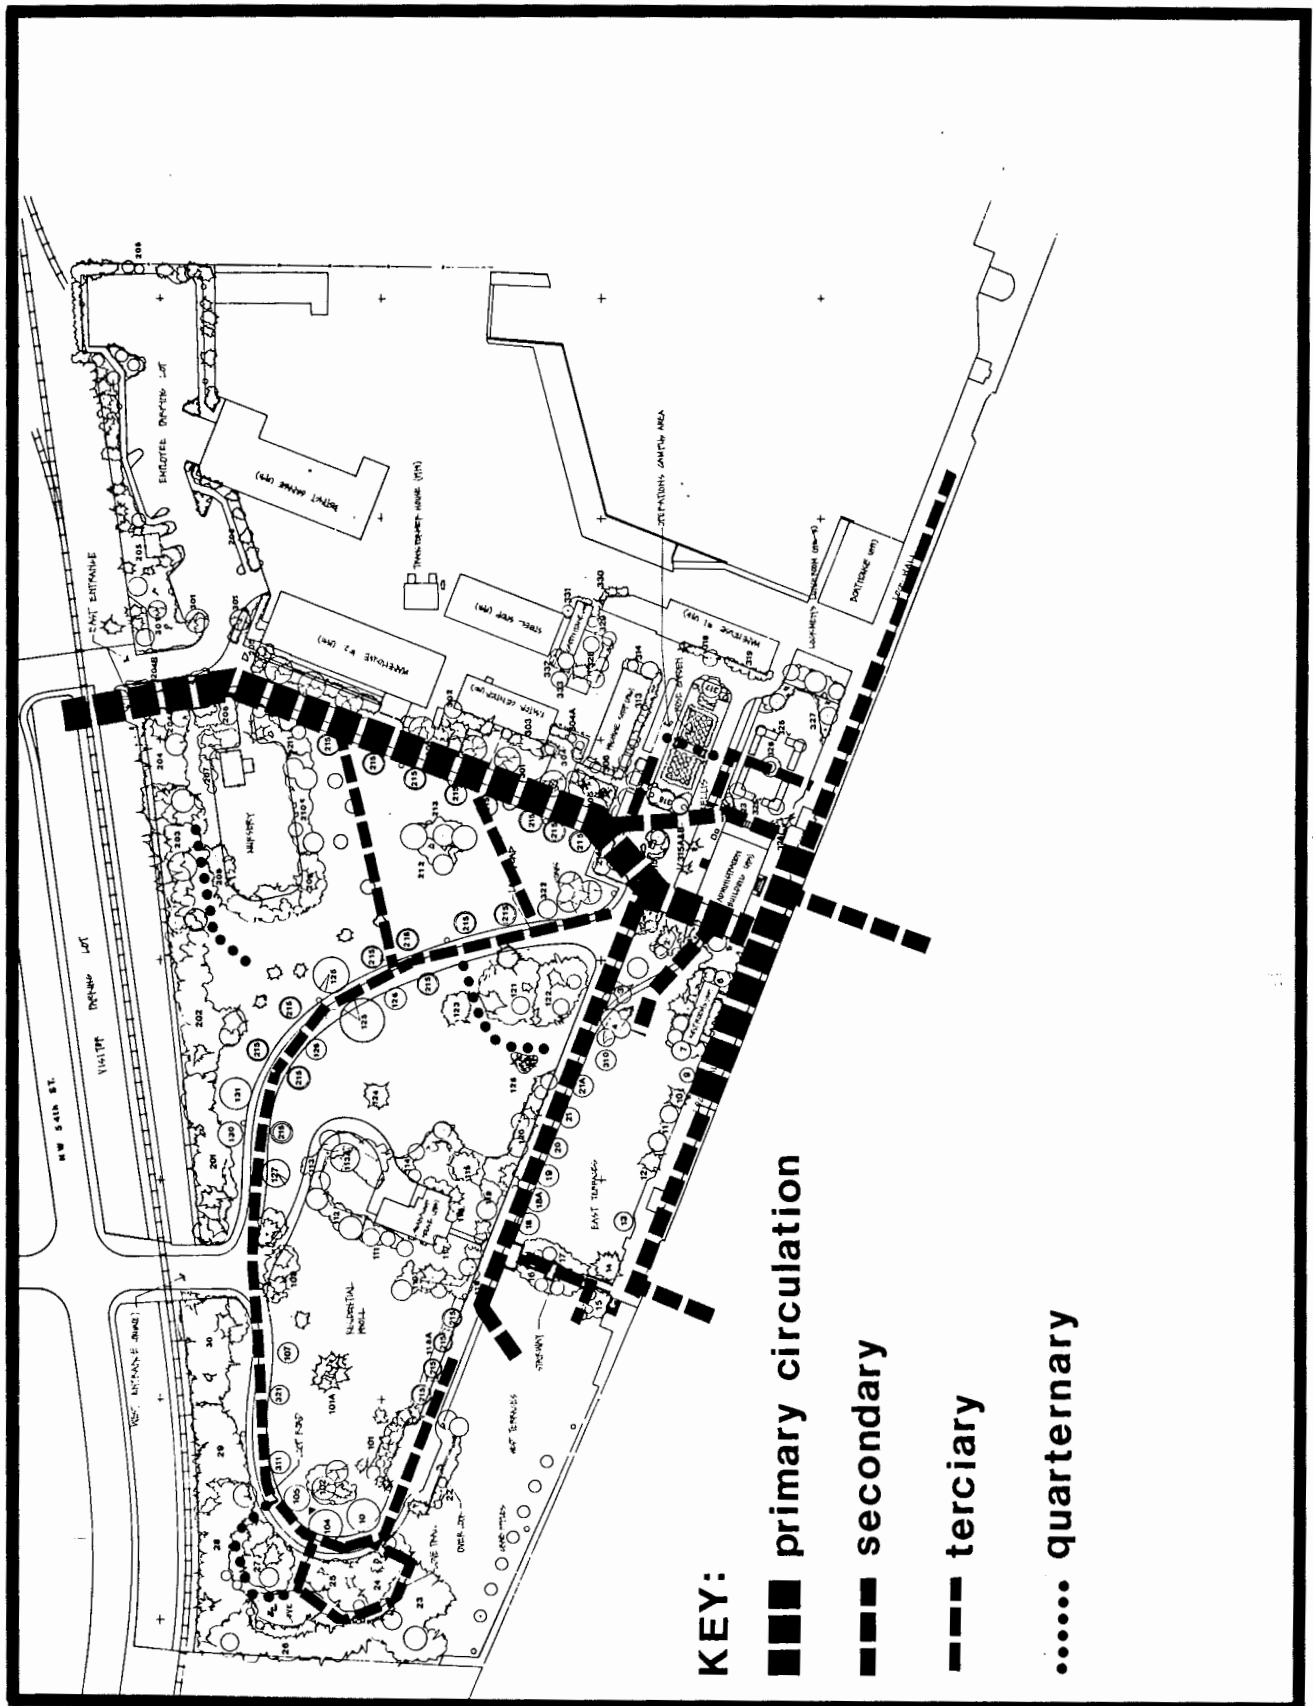
Map J. Pedestrian Circulation within the Garden

Map J shows generalized levels of circulation traffic through the site. As stated above, circulation within the reservation was historically open to automobiles. The north west entrance was used by the public and cars parked along the loop road. Given this, visitors were most likely spread throughout the grounds more than is found today where the visitors are concentrated along the north east entrance walk and lock wall. Today primary visitor circulation through the grounds is in a north-south direction from the visitor

parking lot through the north east entrance gate and plaza, down the entrance walk (with approximately 15% of the visitors stopping at the Visitors Center), past the Administration Building on the west side, and to the lock wall. The flower beds may attract some visitors to pass on the east side of the Administration Building

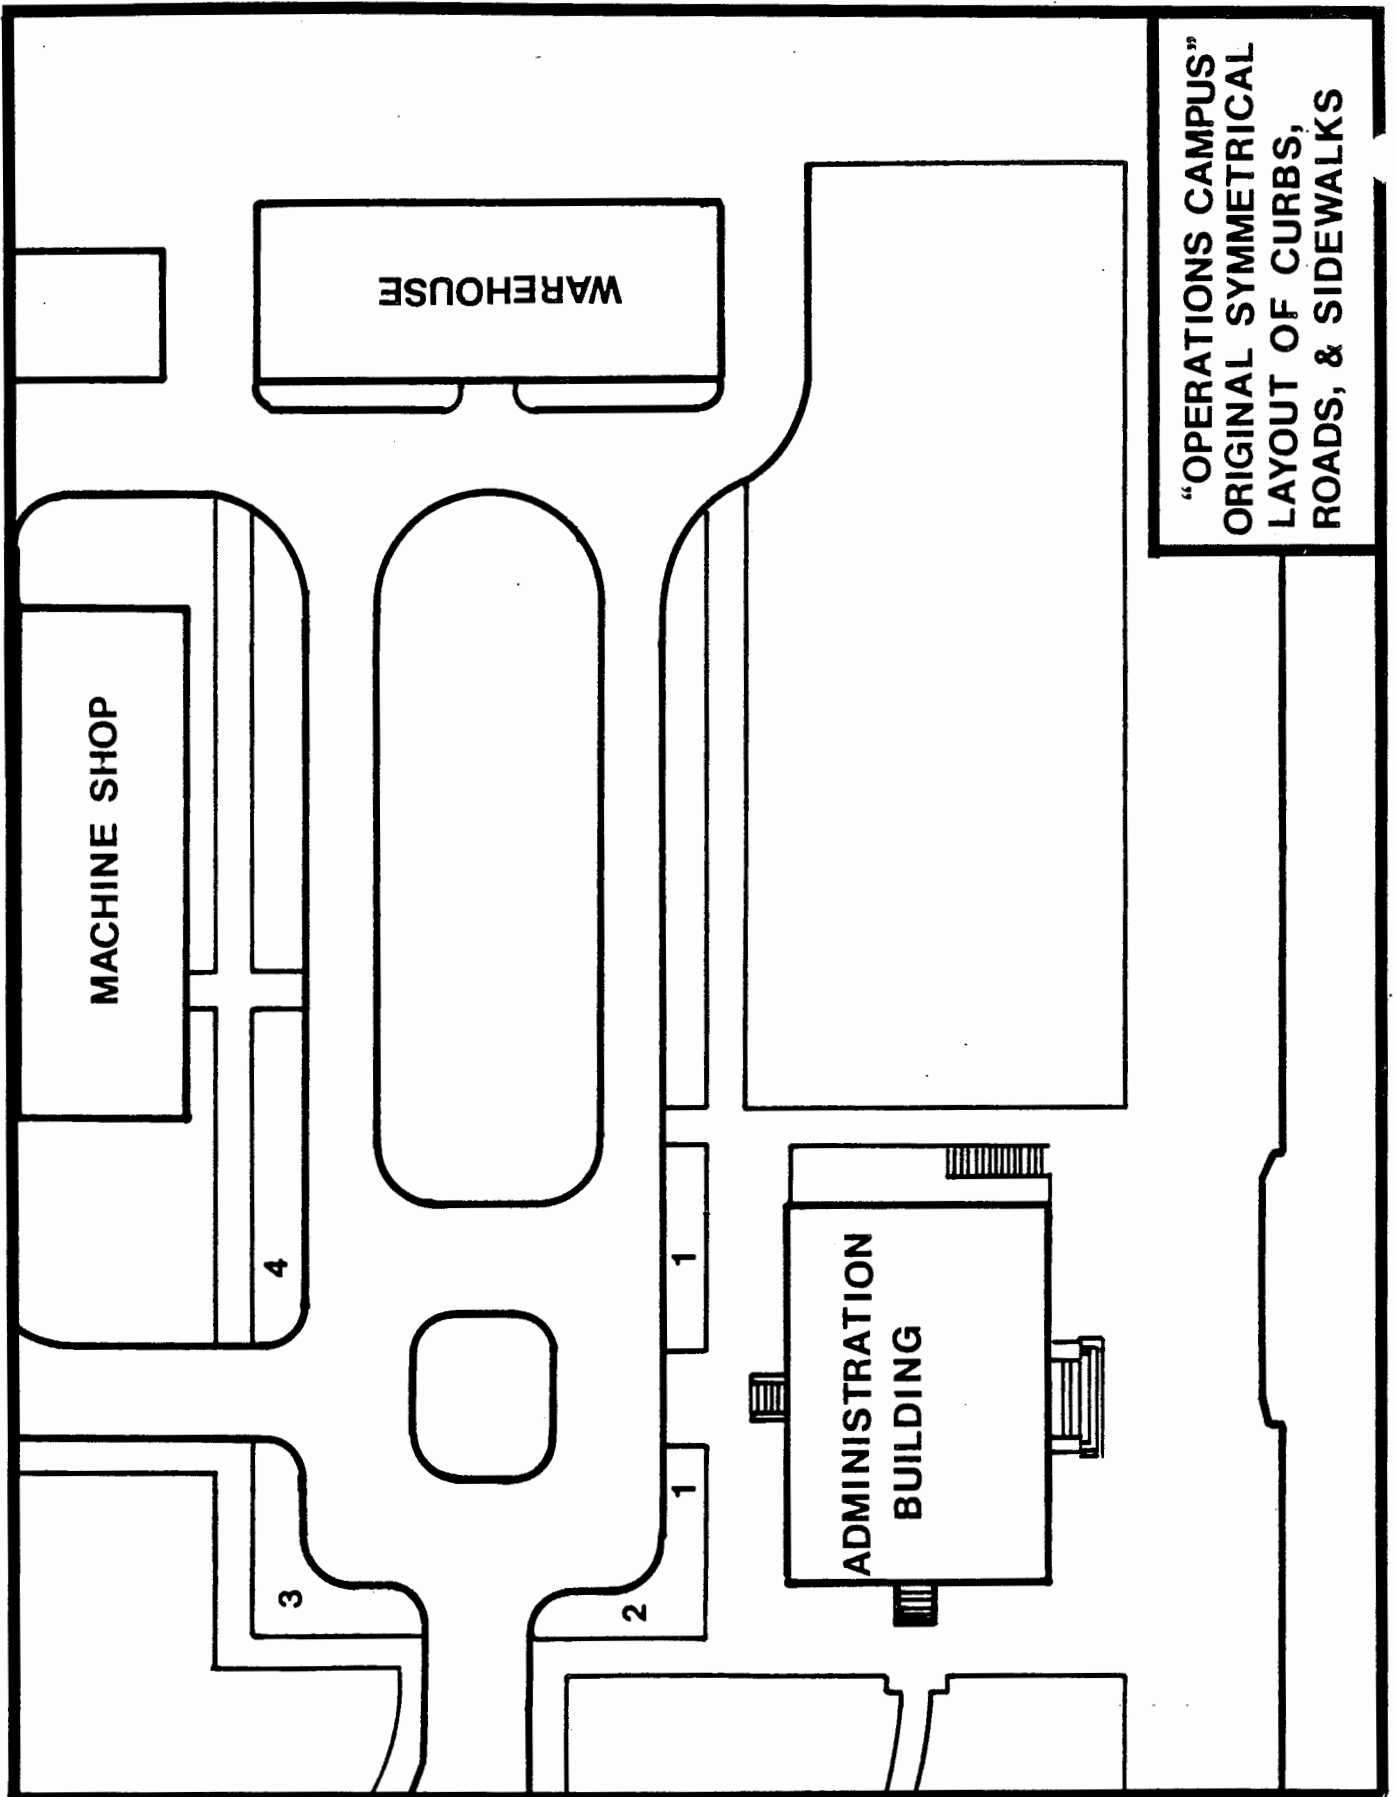
Map K. "Operations Campus" Area Showing Original Symmetrical Layout of Curbs and Sidewalks. (from 1920 map LWC290)

The even placement of trees along the roadways and sidewalks is another repeated landscape pattern found on the site. Trees are located between 20 and 40 feet on center and, given the number of trees drawn on early plans, may have been closer originally. The

**"OPERATIONS CAMPUS"
ORIGINAL SYMMETRICAL
LAYOUT OF CURBS,
ROADS, & SIDEWALKS**

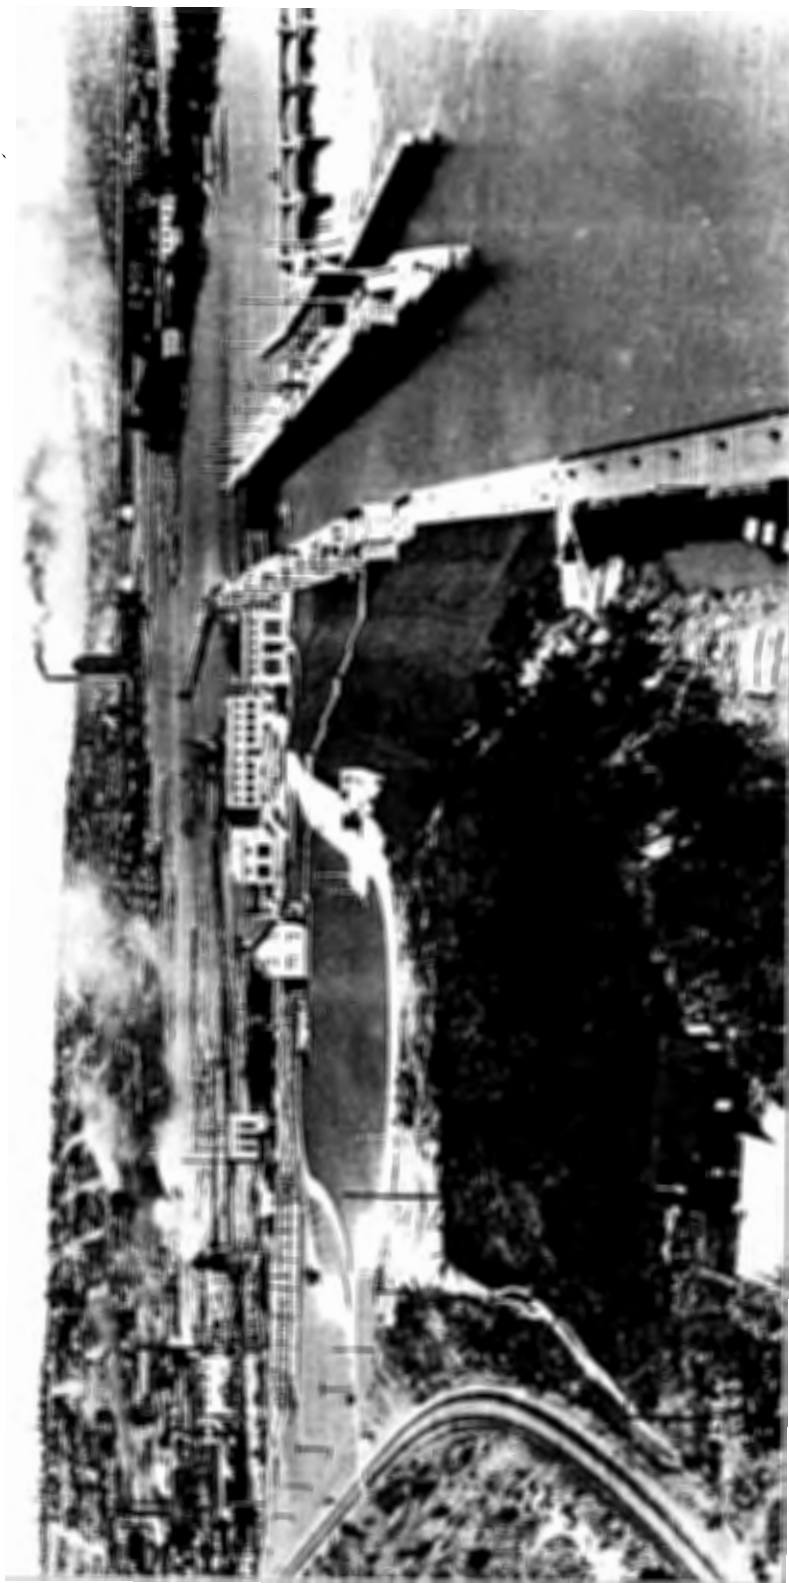
PHOTO 1: Early 1916. Shows lock reservation looking east. [1, 2, 3, 101, 108, 109, 206-211, Cove, tennis court]. (no LWSC number)

- 1 Bed 1 shows up in the 1918 map as a group of shrubs. A 1916 photograph (photo 1) shows 2-3 evergreen trees in this location. Photographs from 1929 -1932 and 1937 (photos 8, 10) no longer show these trees but a serpentine shaped flower bed is located in their place. Koykka states that this bed "was originally landscaped before Mr. English came" but the plantings were less complex. The walk-way between the Administration Building was widened in 1943 and the landscaping redone. A 1962 photograph (photo 26) shows a well defined crescent shaped bed. Today the plant material in this and surrounding beds is much larger, casting shadows and leading to the death of much of the grass lawn which once surrounded them. Since 1974 some plant material has been moved to Bed 327 due to its large size.

- 2 As with Bed 1, the 1916 photograph (photo 1) shows a tree in the location of this bed. This single deciduous tree shows up in late 1920's photographs (photos 7, 8) as well. The now existing cedar of Lebanon was planted as a very small tree in this location in 1934. A photograph from 1937 (photo 10) shows a small Cedar of Lebanon surrounded by a low shrub. By 1940 the bed appears to have developed to include a variety of understory plants (photo 13). Since 1974 little change has occurred to this bed other than winter loss.

- 3 The 1915 revised planting plan calls out an azalea bed here. This was not implemented but 1916 and 1920 photographs (photos 1, 4) show a single evergreen tree at this corner. The 1918 planting plan shows a clump of shrubs in this location but expansion beyond the single tree does not appear until 1940 photographs (13). Since 1974 this bed has lost five plants but little has changed concerning its triangular shape.

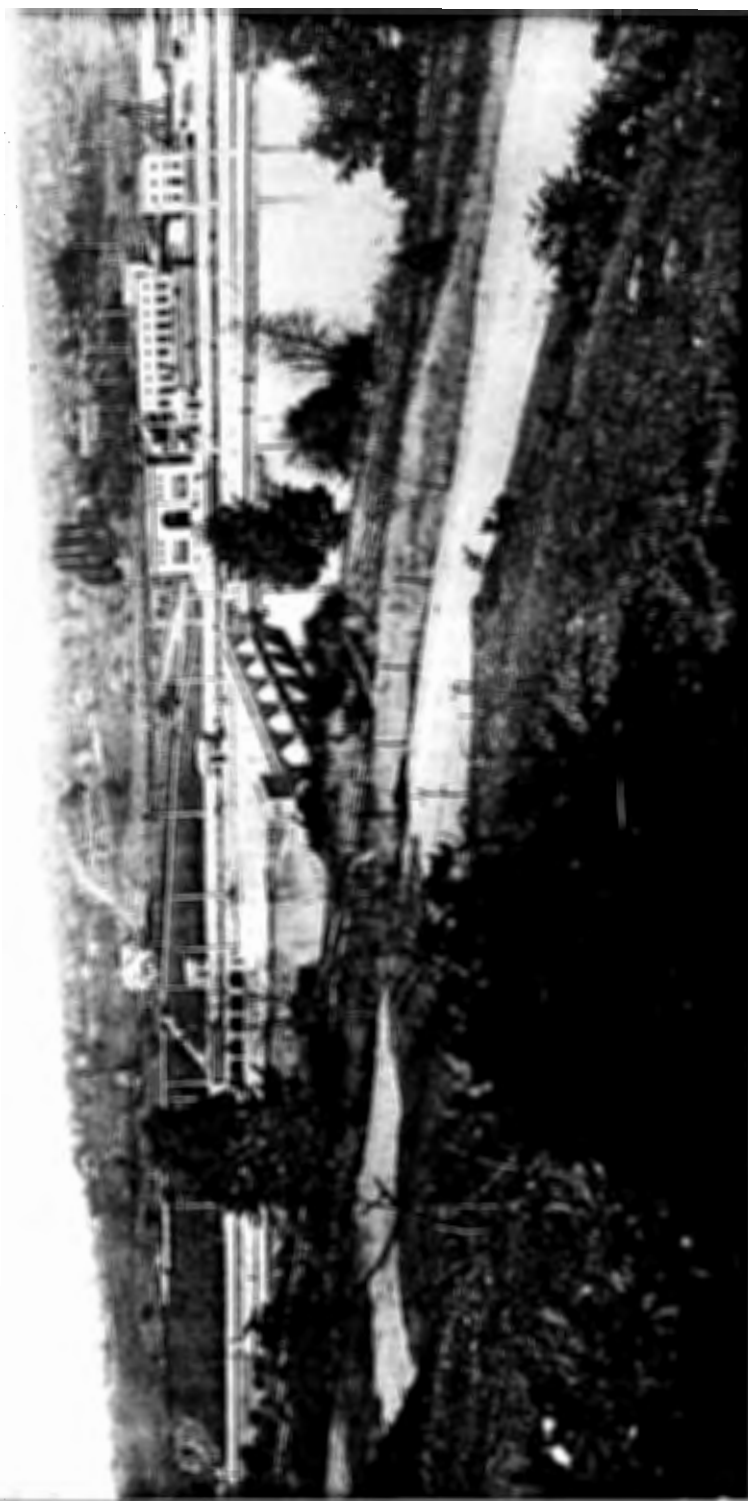
PHOTO 4: Summer 1920. The locks grounds looking north from the south side of the canal. [3, 20, 128, 305, 313, 325 A & B, the hedge along the entrance walk, the Cavanaugh House, and tennis court]. (P-59)

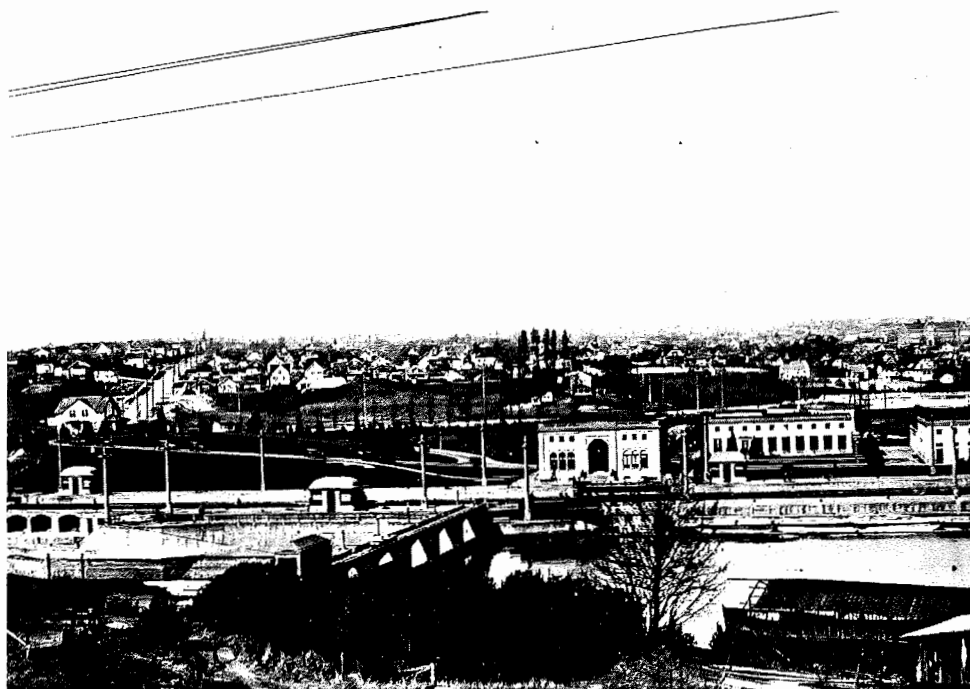
PHOTO 6: Locks grounds looking north from south side of canal. Outlines of Beds 325 and 326 can be seen in the right hand side of the photo showing that these beds were designed earlier than other garden history reports have stated. This photograph is mis-dated Dec. 1920. The size of specific trees and existence of Beds 325/326 date this sometime in late 1920's. (P-56)

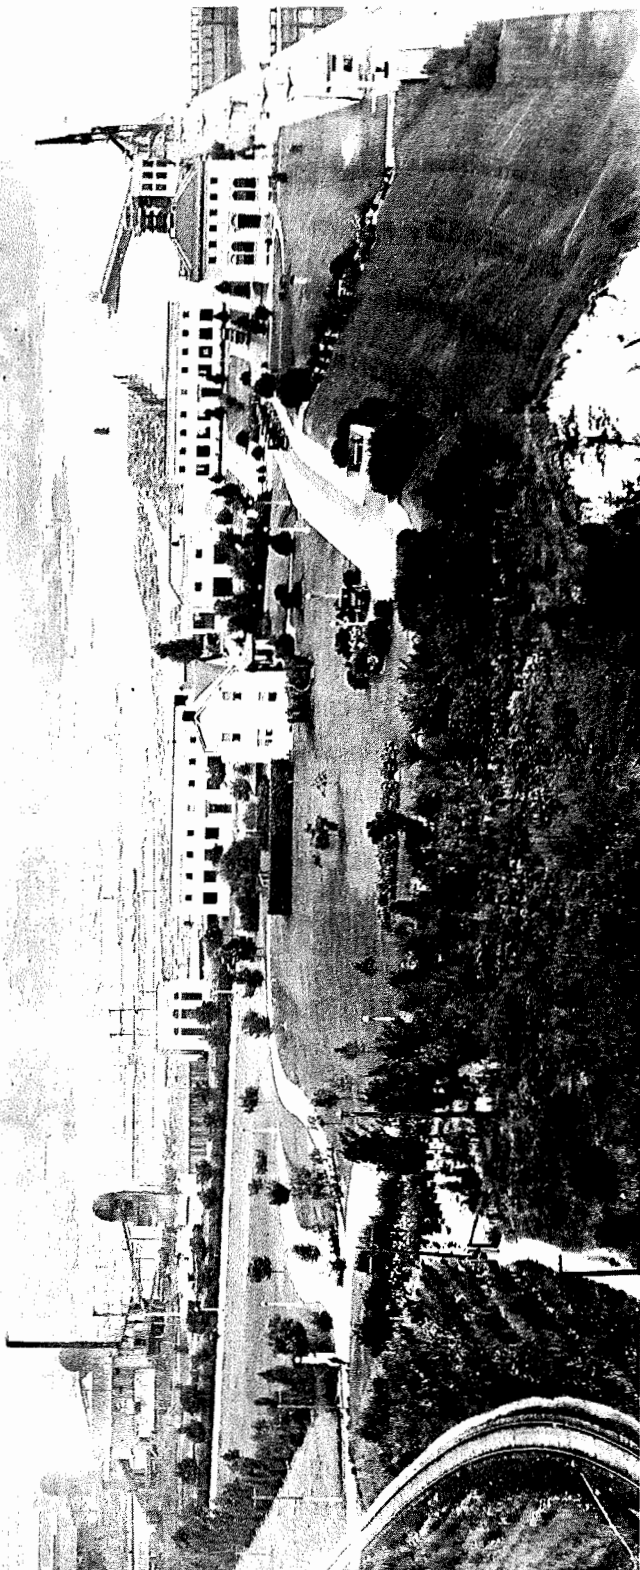
PHOTO 7: 1928. View of reservation from west end looking east. [2, 15A, 16, 17, 22, 23, 101A, 102, 105, 108, 109, 110, 111, 113, 316, 317, 318, 319, front of Cavanaugh House]. (no LWSC number found)

15A 1920 and 1930's photographs (photos 7, 9) show a hedge-like clump of deciduous shrubs in the location which borders a part of the wall sidewalk. A 1948 photograph (photo 18) shows that this rectangular bed was removed. Carl English's 1969 list of plants lists *Fraxinus ornus* (flowering ash) as the sole plant in this location. This tree was killed by contractors' heavy equipment in the mid 1980's. It is unknown as to the origins of the *Liquidambar formosa* next to 15A location which is presently doing very poorly.

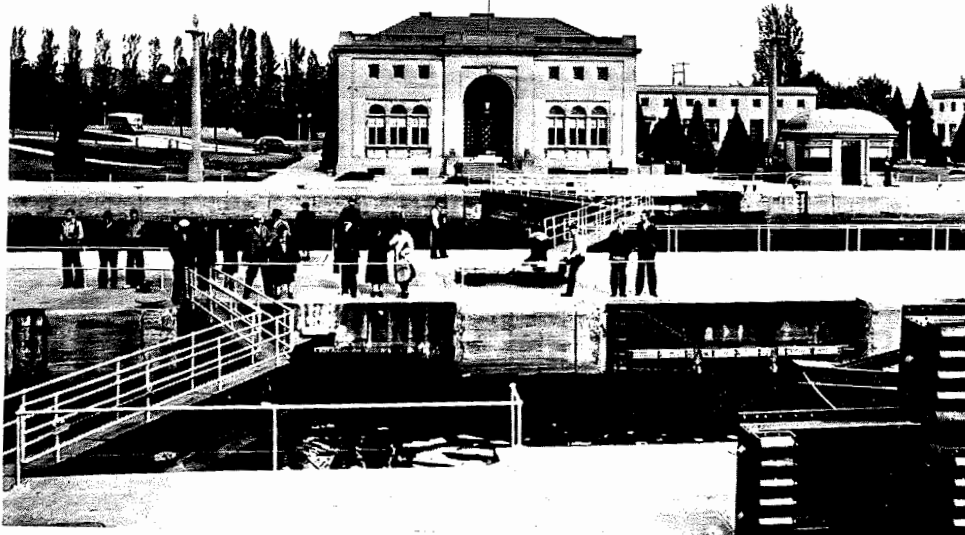
PHOTO 10: 1937. View north to Administration Building from spillway. [1, 2, 5, 12, 323, 324, 325, line of poplars in background, roped off lawn]. (P-2)

- 5 Bed 5 is an original bed location although its shape has changed over the years. This bed and Bed 1 were serpentine shaped flower beds as shown in 1929-32 and 1937 photographs (photos 8, 10). A 1962 photograph (photo 26) and English's map show shrubs and trees in a crescent shaped bed surrounded by grass to the east, south and west. The sidewalk borders the north edge. The lawn was removed due to grading and drainage problems after a new sidewalk and curb were added along the lock wall in the mid 1970's. A number of new plants were added to south-east corner of the bed changing its shape and eliminating access between the bed and the rest rooms.

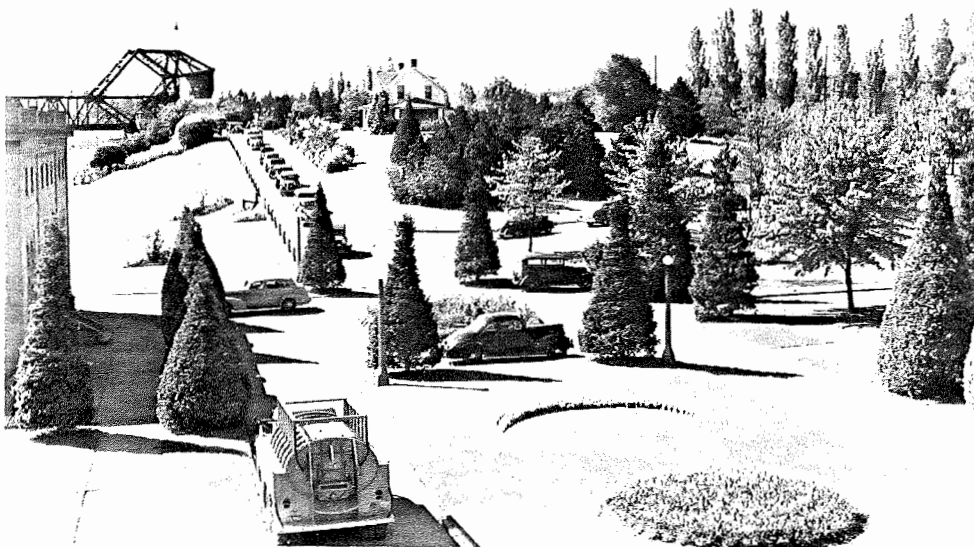
PHOTO 13: 1940. View of reservation from east end looking west.
[2, 3, 4, 316, rose garden area, front of Admin. Bldg.]. (P- 60)

- 4 This elongated triangular bed can be seen in photographs after 1939 (photo 13). An oval shaped flower bed and a single evergreen appear in the area south and west of Bed 4 in a 1916 photograph (photo 3) but this do not appear in photographs after 1929. A 1947 photograph (17) shows an irregular "E" shaped to the bed. Other than some plant loss, this bed is essentially the same now as it was when English left.

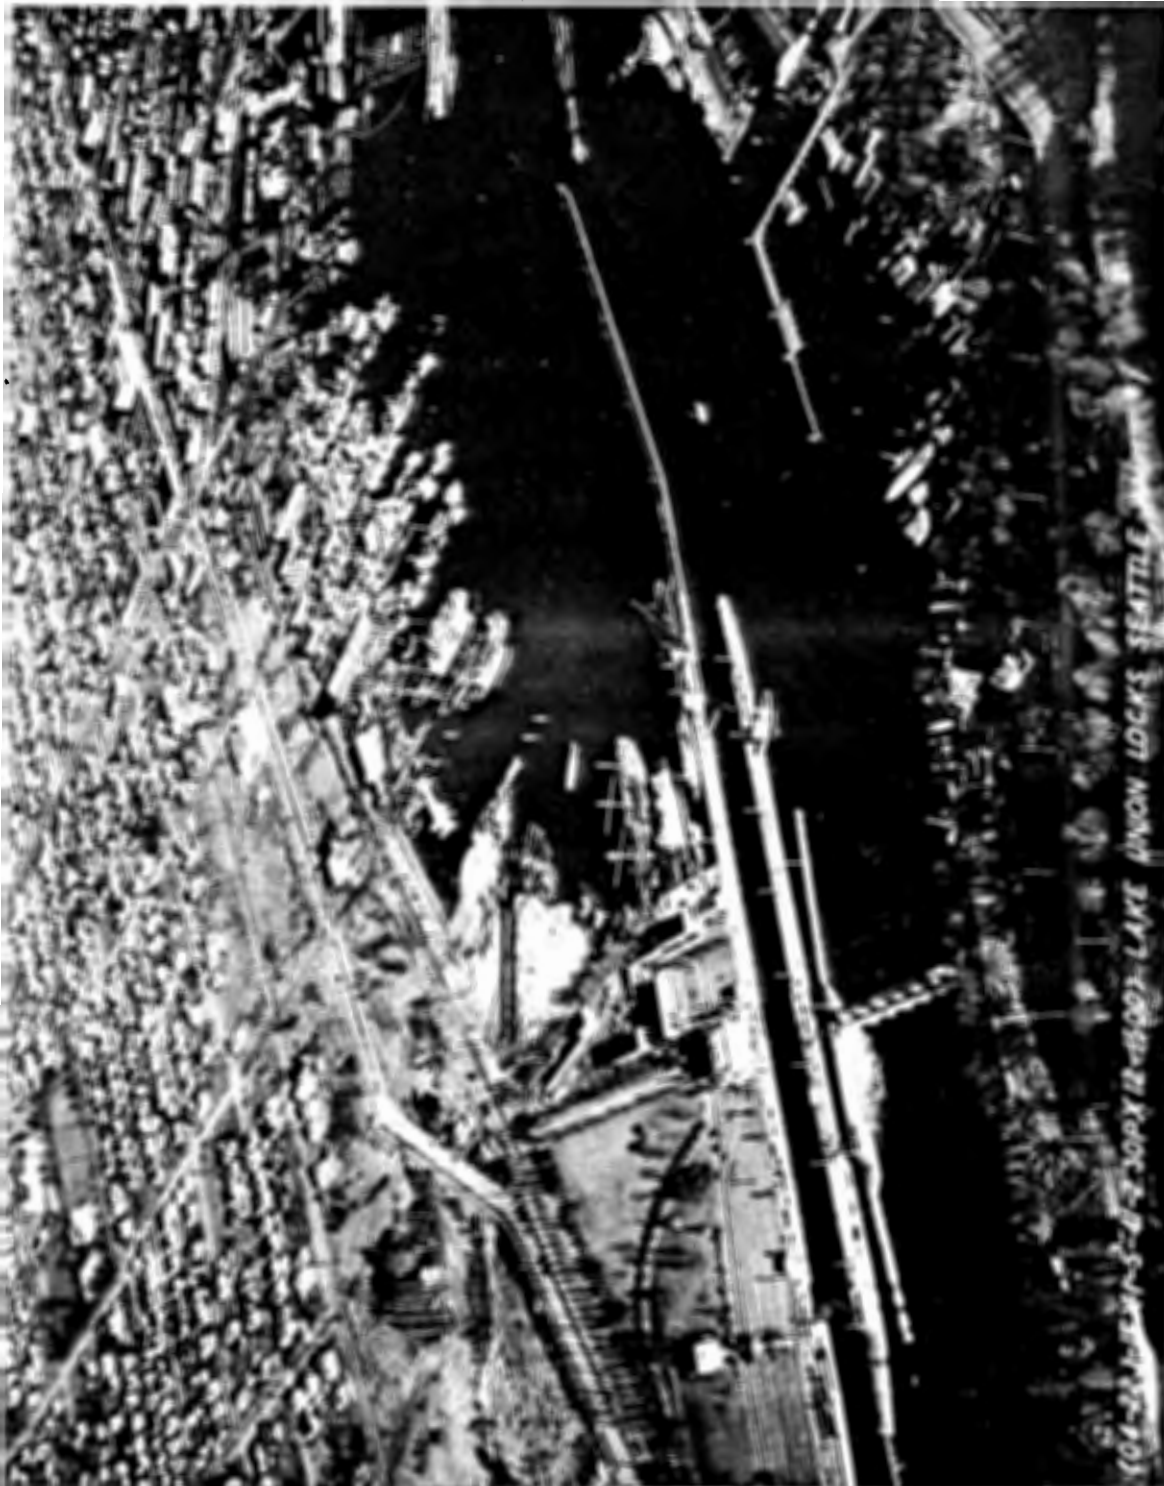
PHOTO 16: 1941. Aerial view of central and east end of reservation grounds. The orderly and formal placement of plant material, especially in the operations campus area, can be seen here. [4, 110, 115, 201-204, 215, 323, 324, 325, 325 A & B, 326]. (LWSC 69)

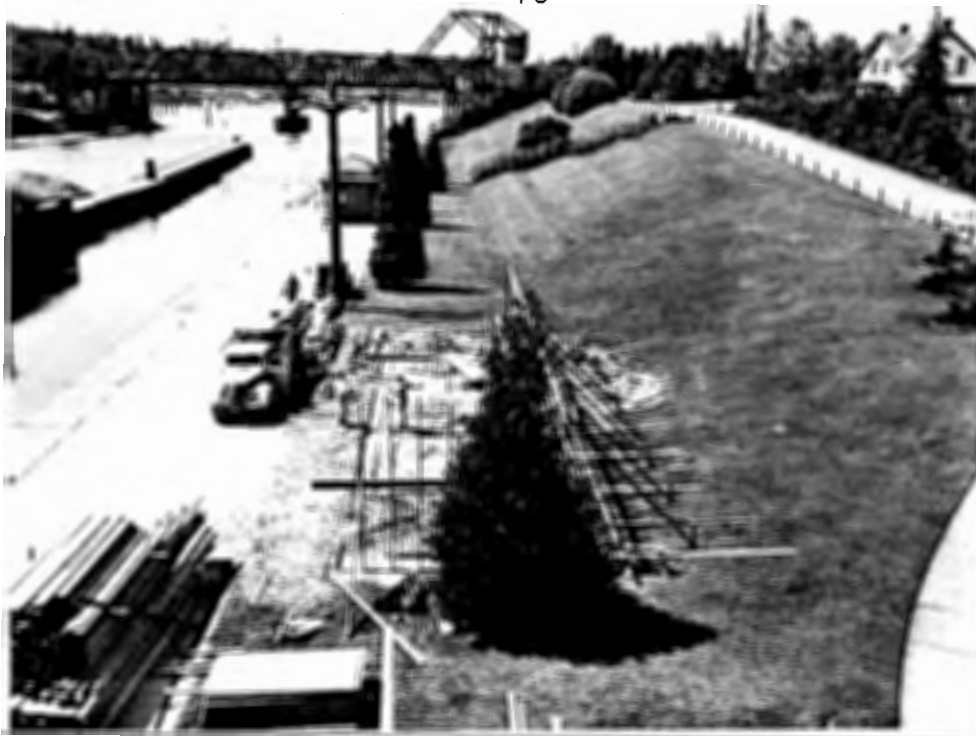
PHOTO 17: 1947. View west from the top of the Admin. Bldg. Construction of rest rooms. [4, 16, 17, corner of Bed 5, barrier at top of terraces]. (LWSC 513)

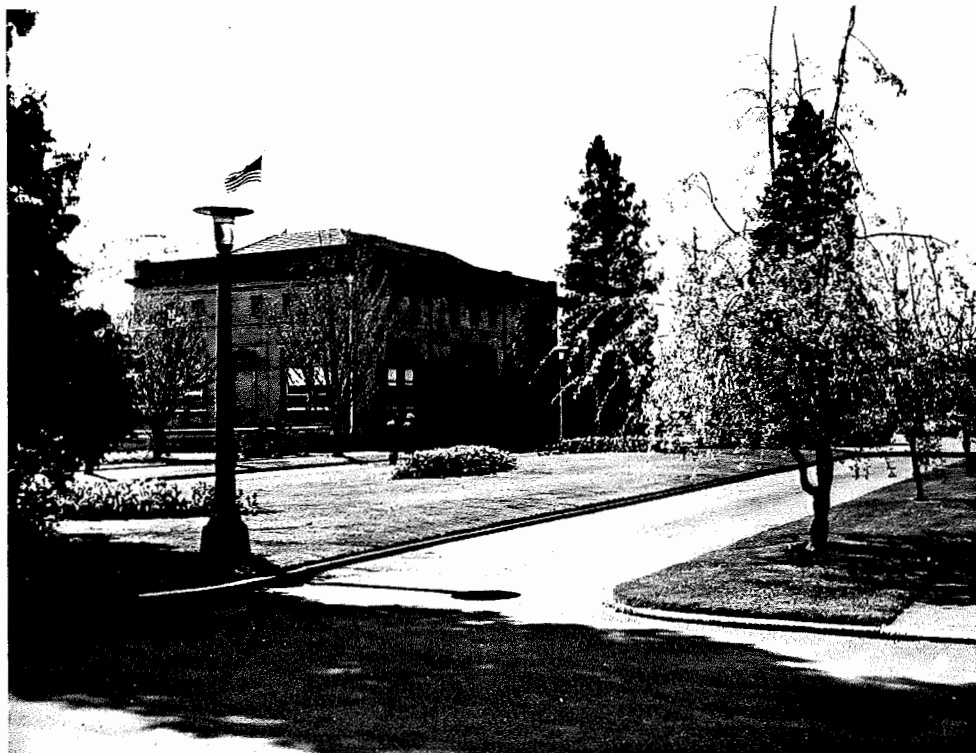
PHOTO 25: 1962. Operations campus area showing crescent shaped beds where rose garden now exists. [312, 316, 321, 323]. (LWSC 953)

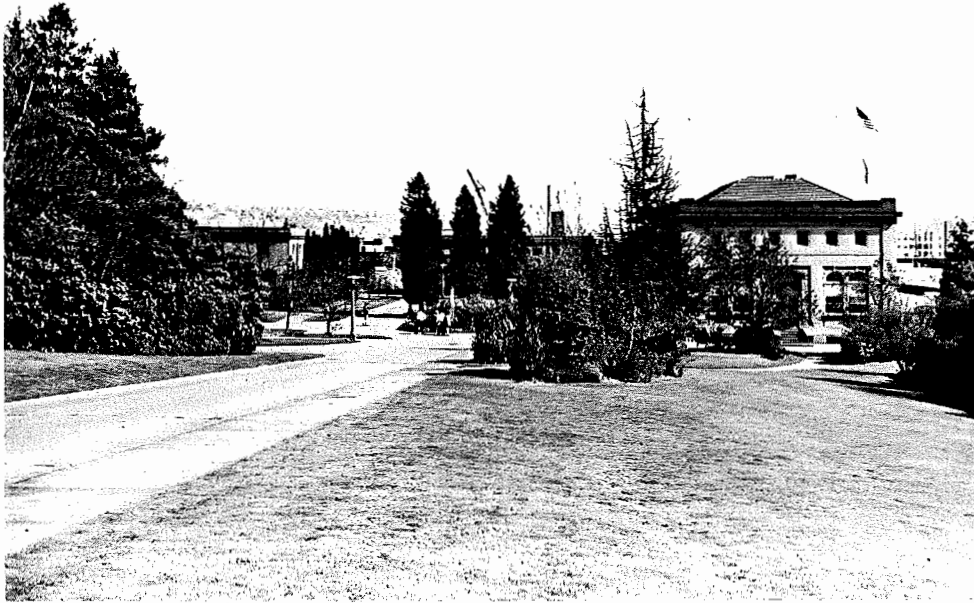
PHOTO 26: 1962. View east toward sub-area B5 and operations campus area from terraces. [1, 3, 4, 5, 12, 121/122, 309]. (LWSC 951)

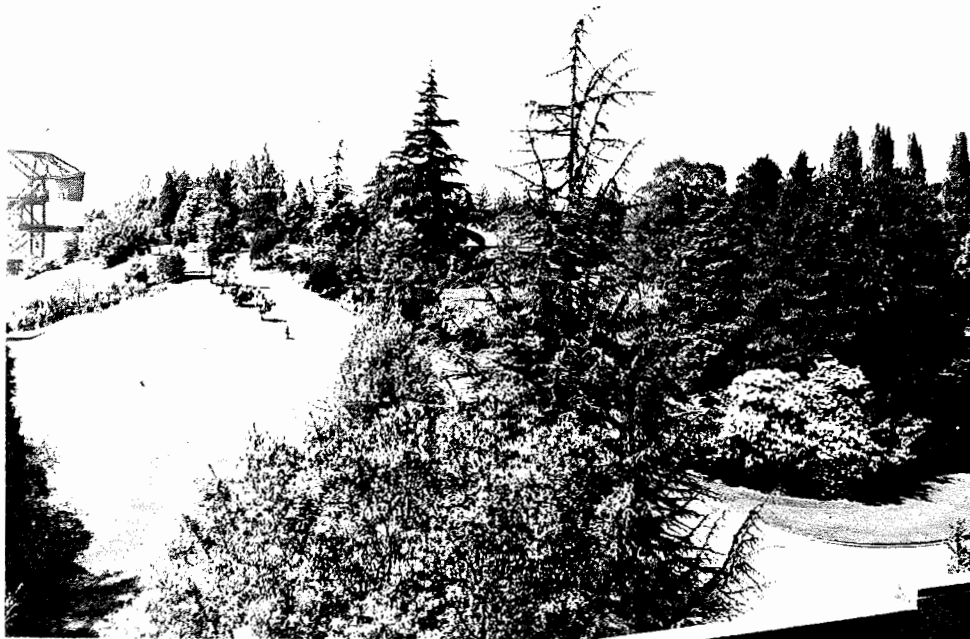
PHOTO 32: View west over terraces and along straight leg of the loop road. Diversity in Beds 16 and 17 can be seen at this point. (LWSC 1354)
