HISTORIC GROUNDS REPORT
THE CARL S. ENGLISH, JR. BOTANICAL GARDEN
AT THE HIRAM M. CHITTENDEN LOCKS
SEATTLE DISTRICT, CORPS OF ENGINEERS

PREPARED BY RENEE L. FREIER
NOVEMBER, 1989

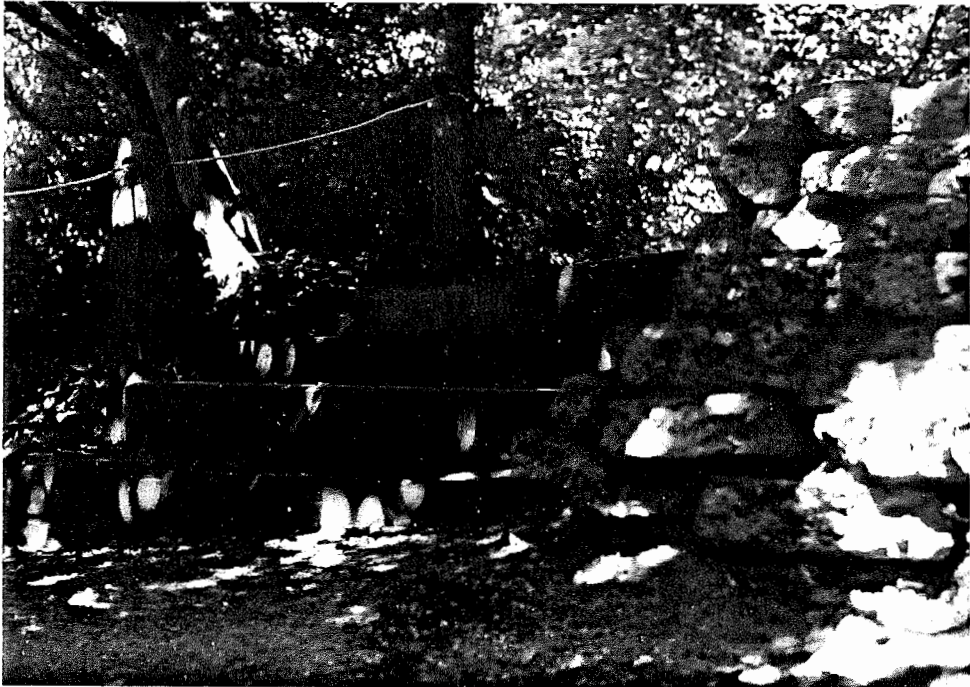
The "Cove", a small opening within a thickly wooded area at the far west end of the reservation, is sub-area B4. A patch of grass lying at the center of the opening is edged by a wide gravel trail on the east and south sides. Three entrance points access this area: the cove trail from the south, a middle gravel surfaced entrance point, and a north entry which appears very much like a driveway. An original solid concrete bench, similar to those found on the stairway in Area A, is located at the center of the middle entrance. The cove trail leads out from the south end of the cove down 5 railroad tie and gravel steps set at slight angles to each other in order to make a turn toward the east. The gravel trail is edged by wood boards and a concrete post and cable rail marks the south side. Rough concrete chunks are used as a retaining wall at one point along the trail. The short trail takes the visitor down into the wooded hillside and up a tie and wood railing stairway back to the main loop road (photo 35).

rough concrete, and wood decking) are for the most part inconsistent with what is historically found on the site. The use of concrete post and cable barriers along the edge of the trail, though, was found on the site from the 1930's forward. By the fact that the trail can not be seen from other areas of the garden, its visual impact on the historic integrity of the garden is minimal.

PHOTO 35: 1989. Along the cove trail looking east toward the deck stairway leading back to loop road. Notice concrete and cable barriers.

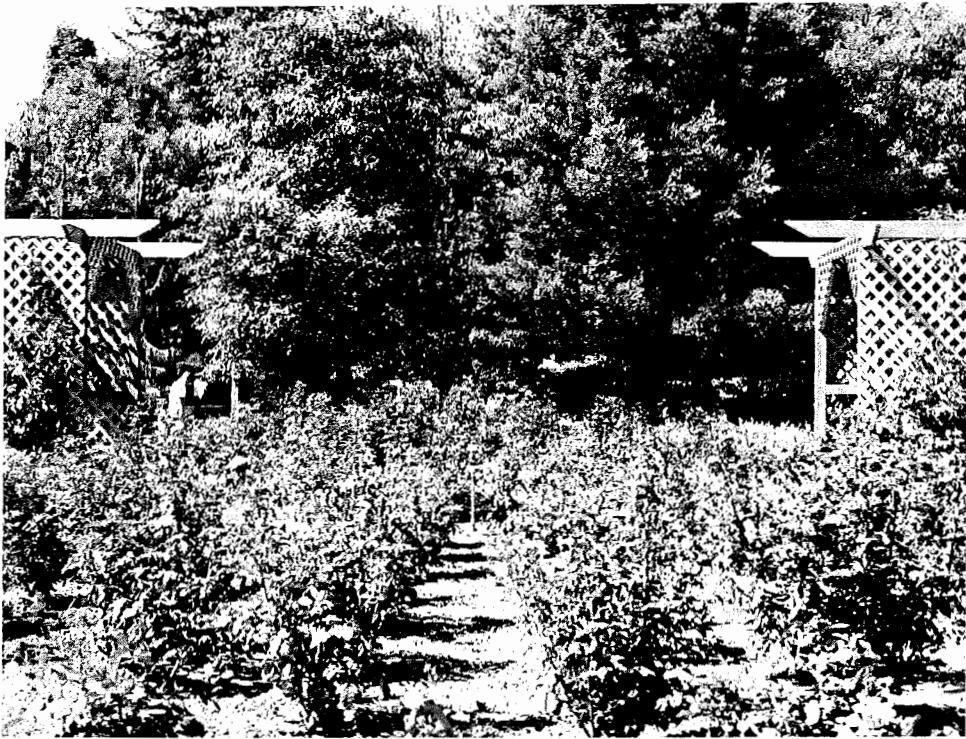
The trellis in the rose garden is not typical of the structures found in the garden. Although the wood used in the trellises' construction is consistent with the wood fences erected by Eckerstrom and English, free standing garden furniture such as this are not found in any historic photographs. (See point 19b, Section 5.03)

PHOTO 36: 1989. Rose garden added in place of crescent beds in operations campus area. Looking west toward Bed 316 and two wood lath trellises built by maintenance personnel.

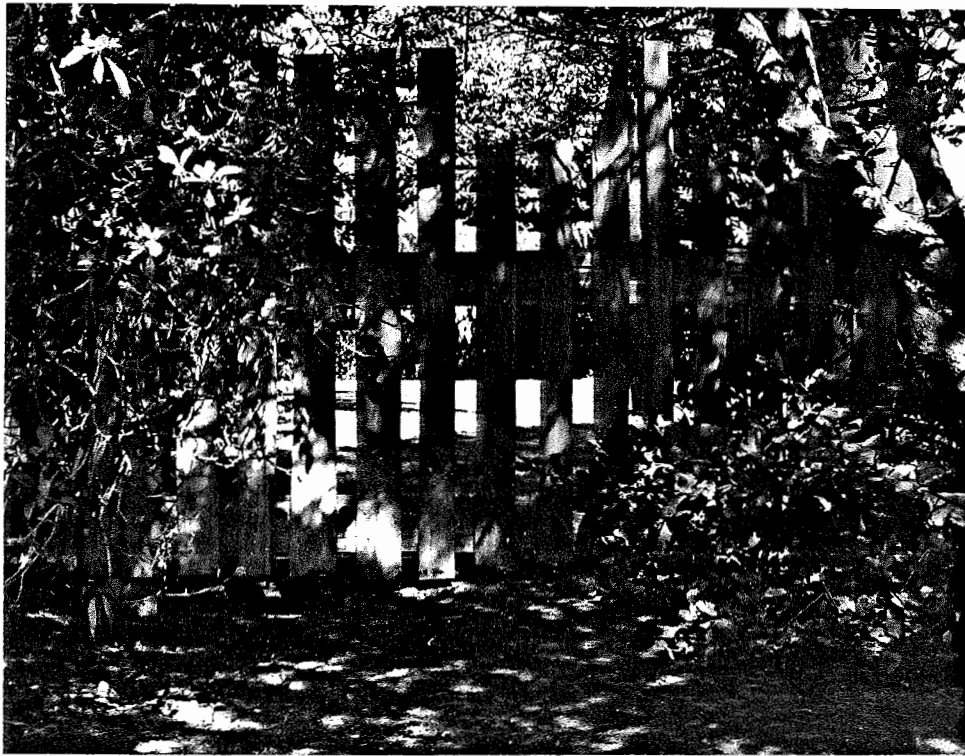
Area A runs adjacent to and parallel with the lock wall and waterway. The five foot terraces characterize this area (photo 38). The straight lines of the lock wall are repeated in the terraces, the lines of trees found both at the top and bottom of the terraces, and in the road and walkway at the top of the slopes. This area is steep with an elevation gain of over 35 feet at the western (steepest) end. The steepness and terraces taper off toward the east end.

PHOTO 38: 1989. West half of terraces in Area A. Line of crab apples can be seen at the bottom of the slope.

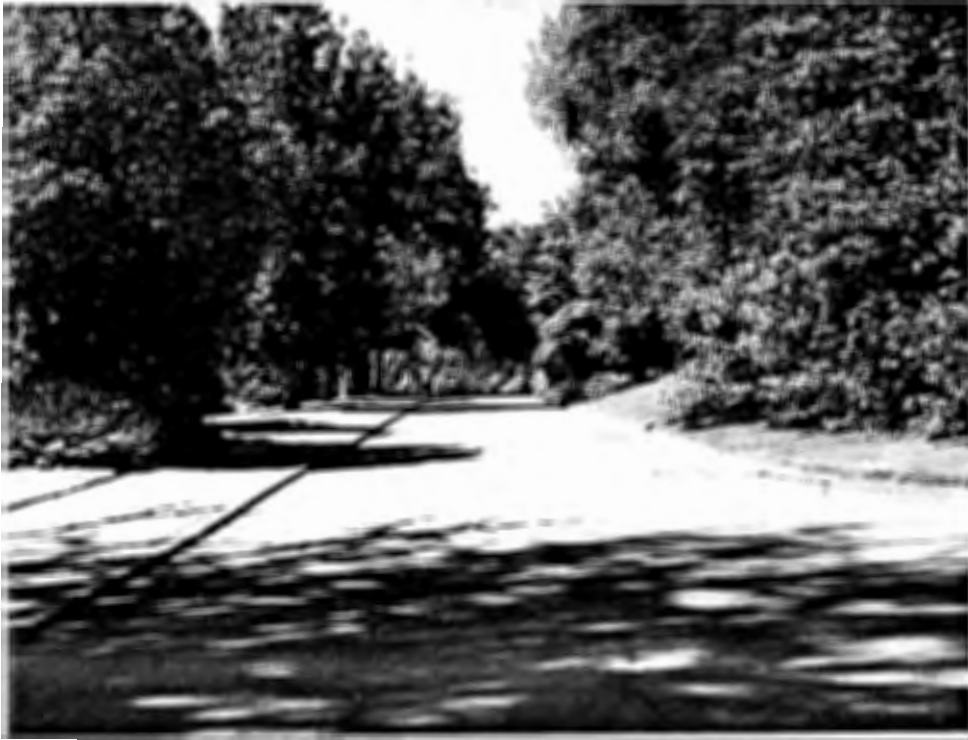
The quality of workmanship and detailed design found in the construction of the overlook retaining wall, concrete stairway and landings, gate posts, and lamp posts are important to the overall character of the garden. (See discussion under Patterns)

PHOTO 39: 1989. Stairway and landings bisecting Area A. Beds 16 and 17 lie on either side. Handrail can be seen running down the center.

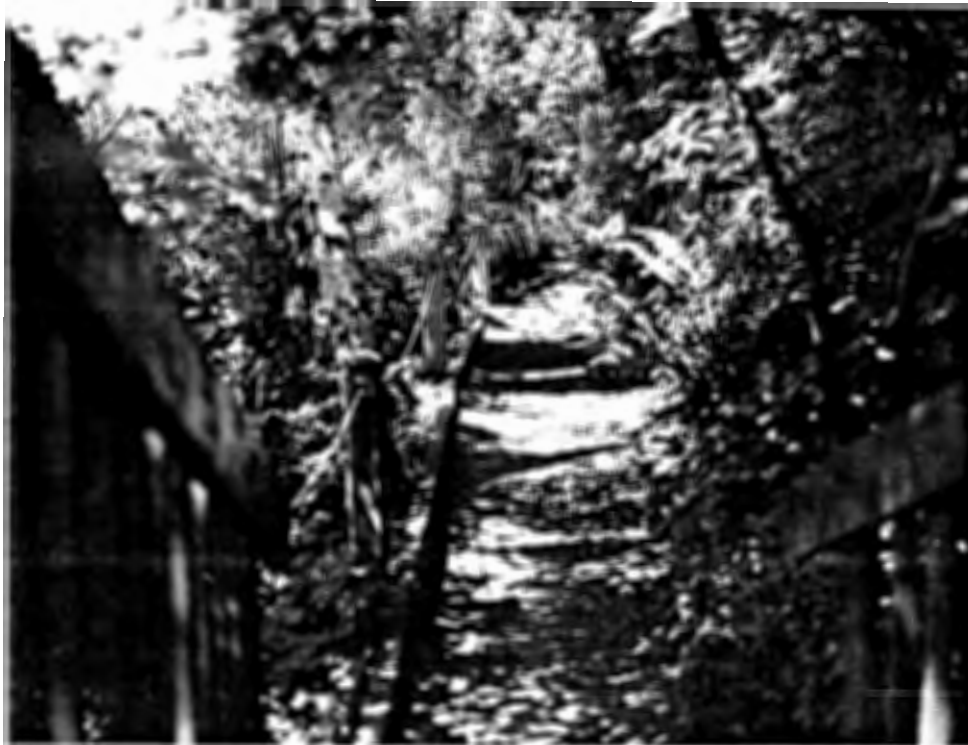
The patterns found within the garden are primarily in the concrete work and in the placement of trees. The overlook retaining wall expresses the quality of the design detail and workmanship given to the initial design of the architecture and landscape structures. The wall is cut into a three step pattern toward the top (photo 40). This pattern is slightly modified and repeated in the exterior base trim of the Administration Building and the Operation Houses. The corners of the stairway landings and the pedestals for

PHOTO 40: 1989. West edge of the Overlook in Area A. The retaining wall and curb patterns can be seen here.

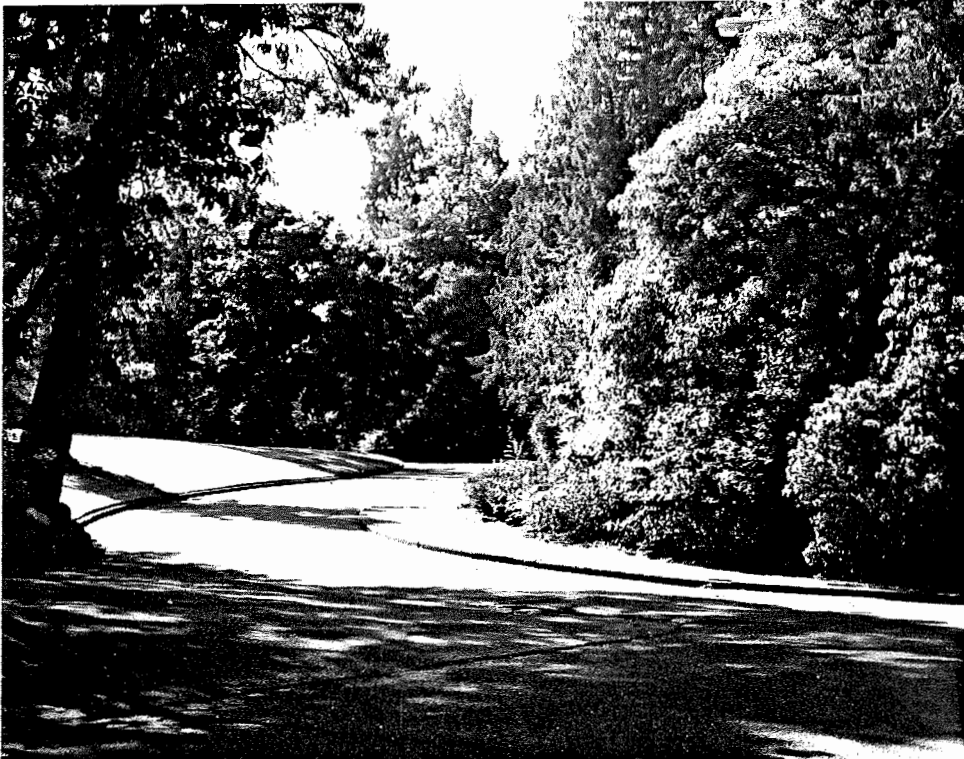
PHOTO 41: 1989. Sub-area B1 open area contrasting with thickly vegetated border around nursery. Beds 209 and 210 can be seen in the background.

20. If a trail is found to be absolutely necessary to draw visitors across sub-area B1 into the garden, locate it along Beds 210 and 209. This will 1) prevent visually bisecting the open lawn and 2) get people closer to the beds.
21. The strong visual lines and patterns created by the original sidewalk layout in the campus area contribute to the historic character of the site and it is recommended that they be retained and re-established (see Map K in 4.01). Given that the endeavor to improve the entrance conditions is being undertaken with Phase II of the Entry Redevelopment, effort to restore the original symmetry of the area north of the Administration Building, rather than reduce it further, should be considered.
